# Navajo Abandoned Uranium Mine Site Screen Report

## **Standing Rock AUM Site**

## **Navajo AUM Eastern Region**

**May 2009**

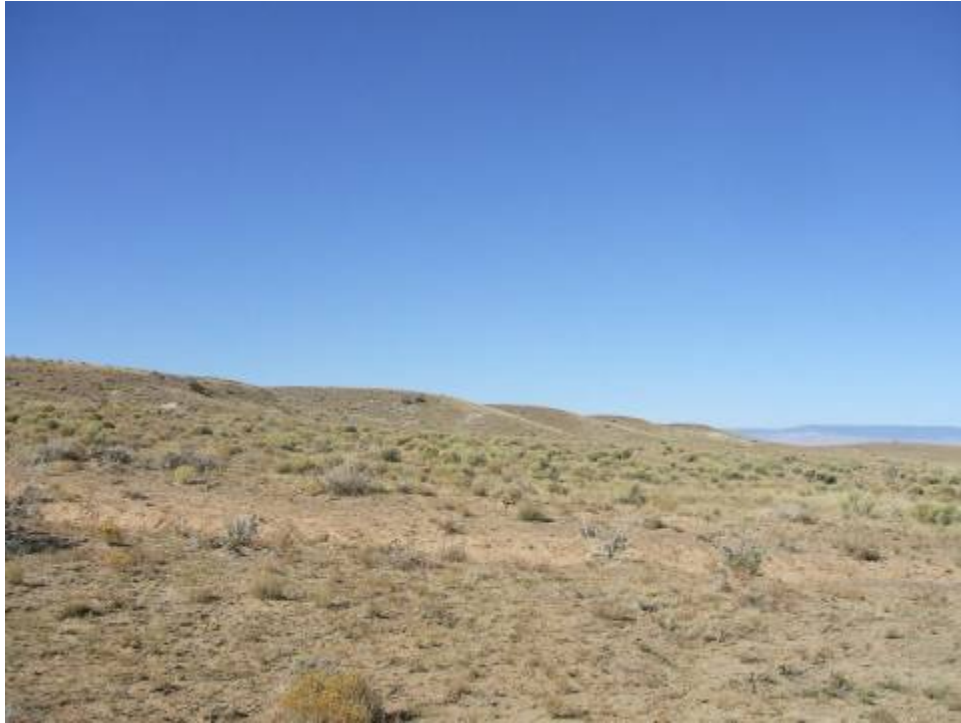
Photo 1. Standing Rock mine site, towards the southwest

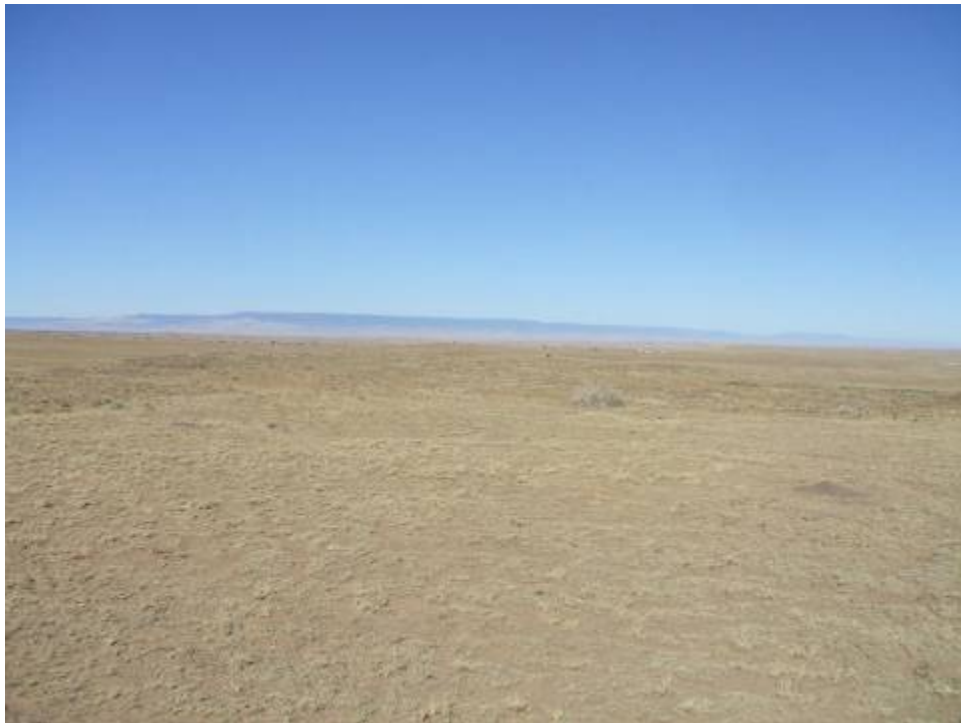
Photo 2. Standing Rock mine site, towards the west

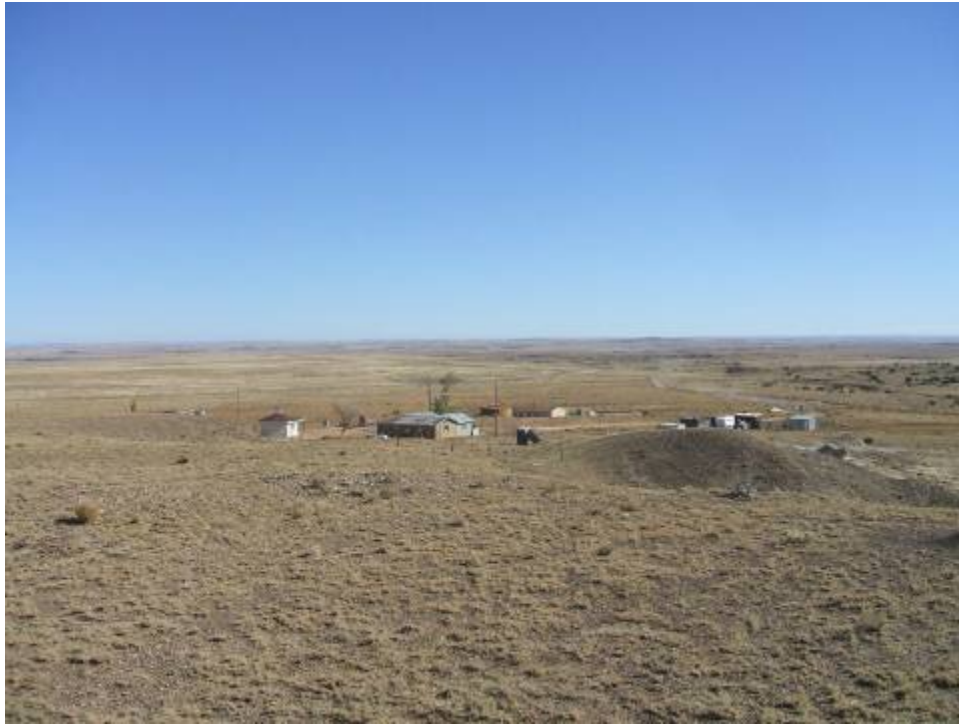
**0 to 200 feet:** 4 homes in located in along the eastern edge of the site along with sheep stable (Photos 3, 10-12). Gamma radiation levels around the homes were found at less than 2 times background levels. Field personnel were unable to gain contact with any of the residents.

Photo 3. Standing Rock mine site and housing compound approximately 50 feet north of site, towards the north

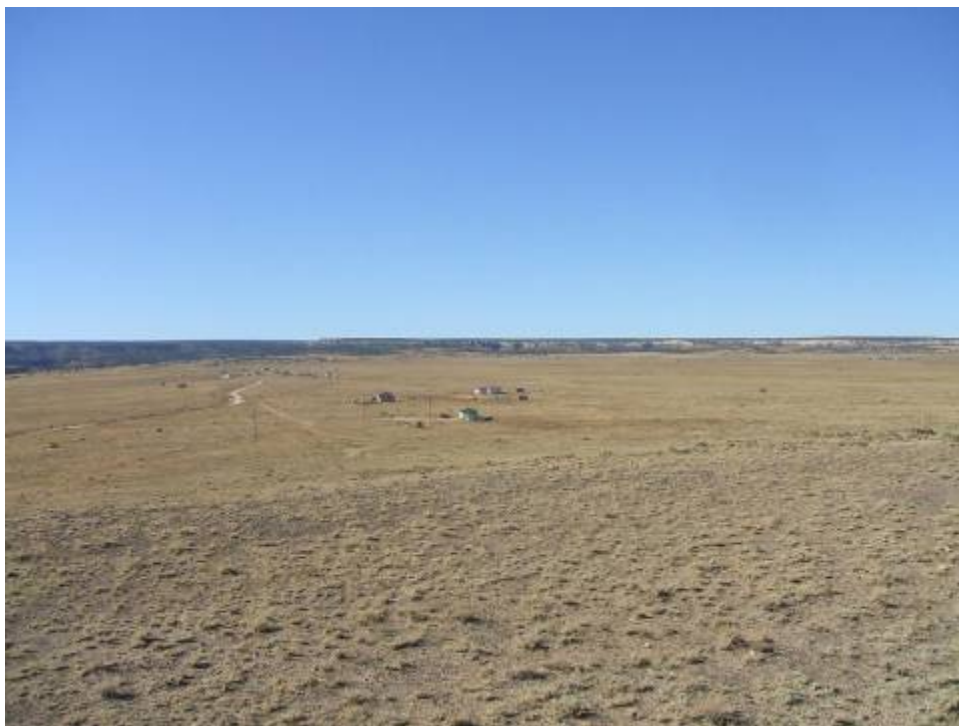
**200 feet to 0.25 mile:** 3 homes were located approximately 0.25 miles south of the site.

Photo 4. Standing Rock mine site and housing compound approximately 0.25 miles south of site, towards the south

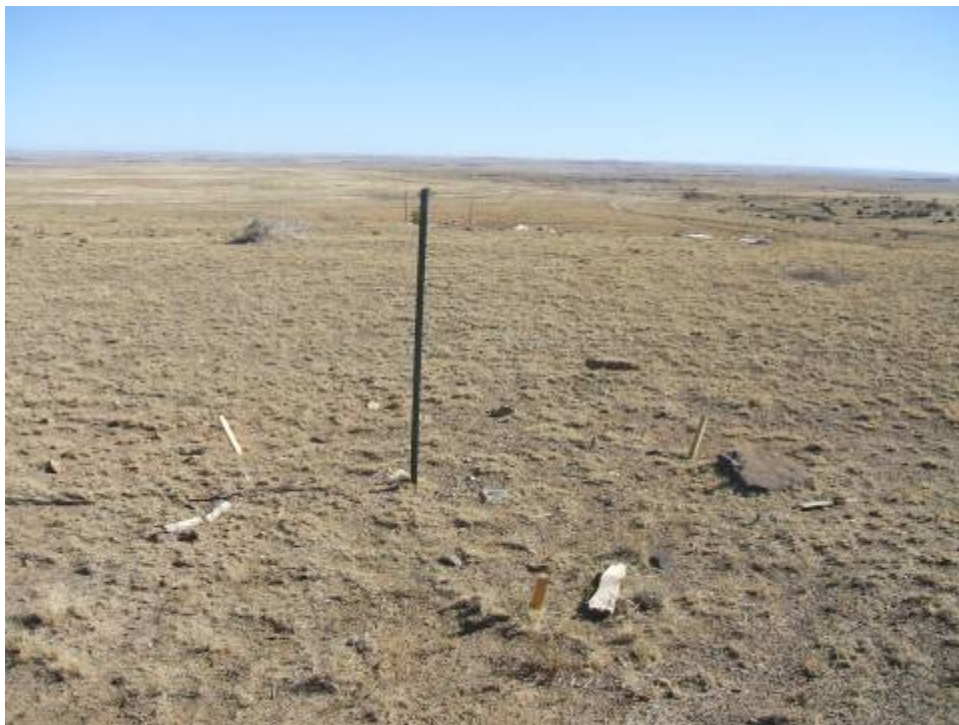
Photo 5. Standing Rock mine site geological survey point in the eastern portion of the site, towards the north

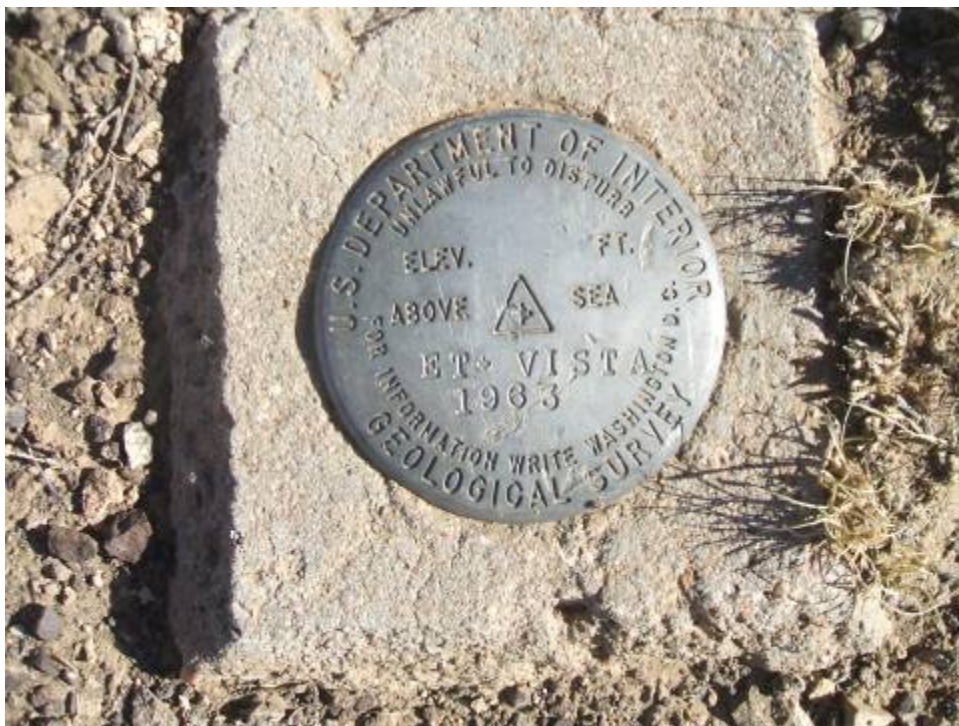
Photo 6. Standing Rock mine site geological survey point in the eastern portion of the site

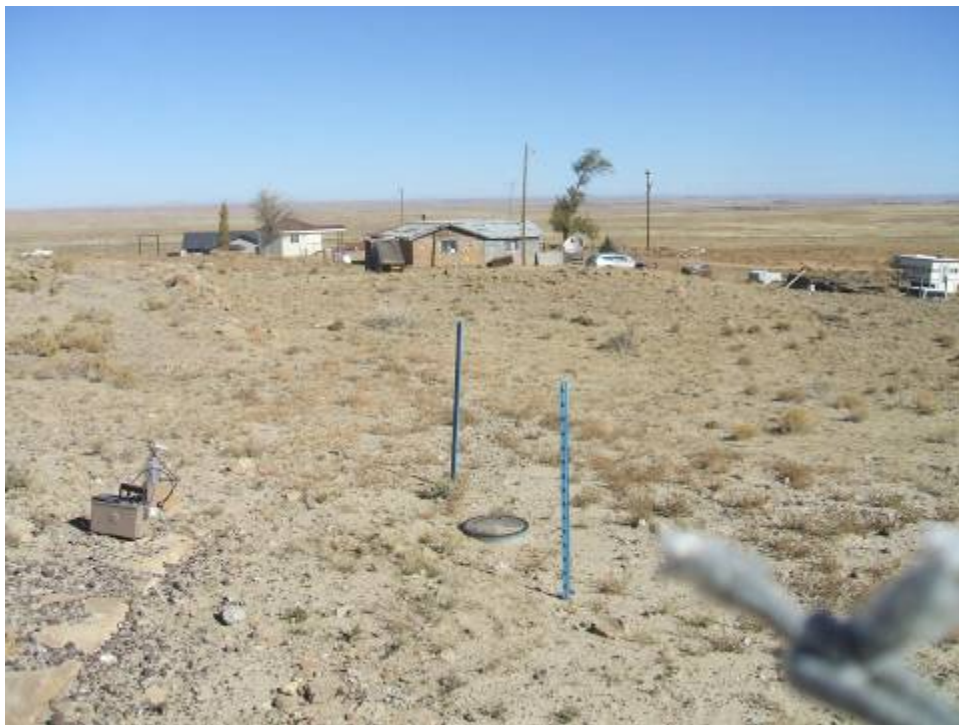
**0 to 0.25 miles:** 4 wells were observed within the area surrounding the east homes (Photos 7-9, 13). Gamma radiation levels were found at less than 2 times background levels.

Photo 7. Standing Rock mine site well at eastern end of the site, towards the north

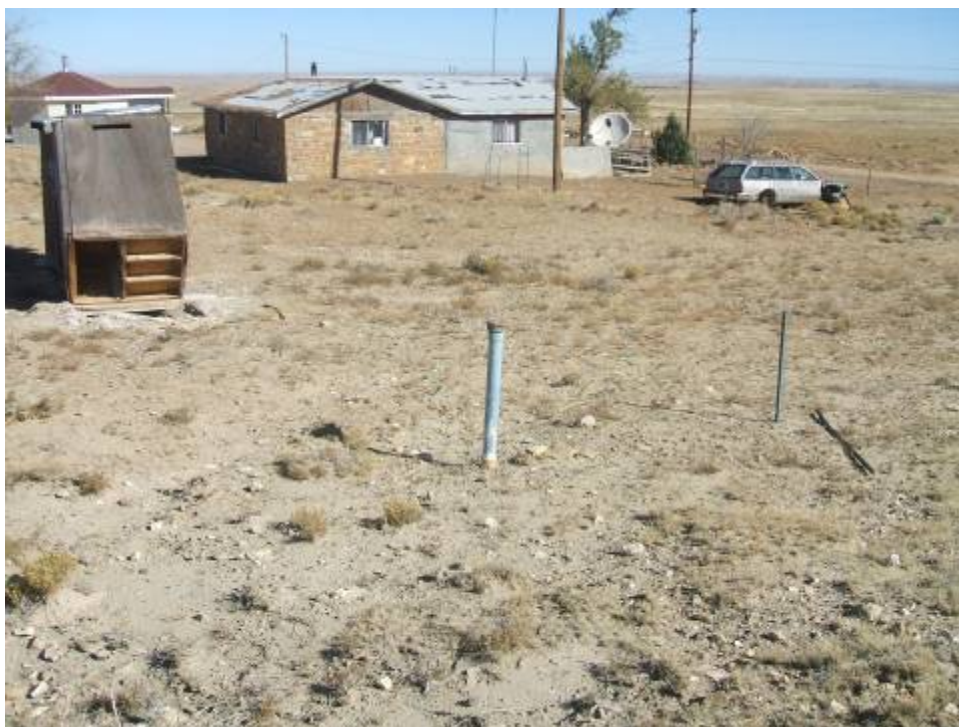
Photo 8. Well located in northern housing compound, directly northeast of mine site, towards the north

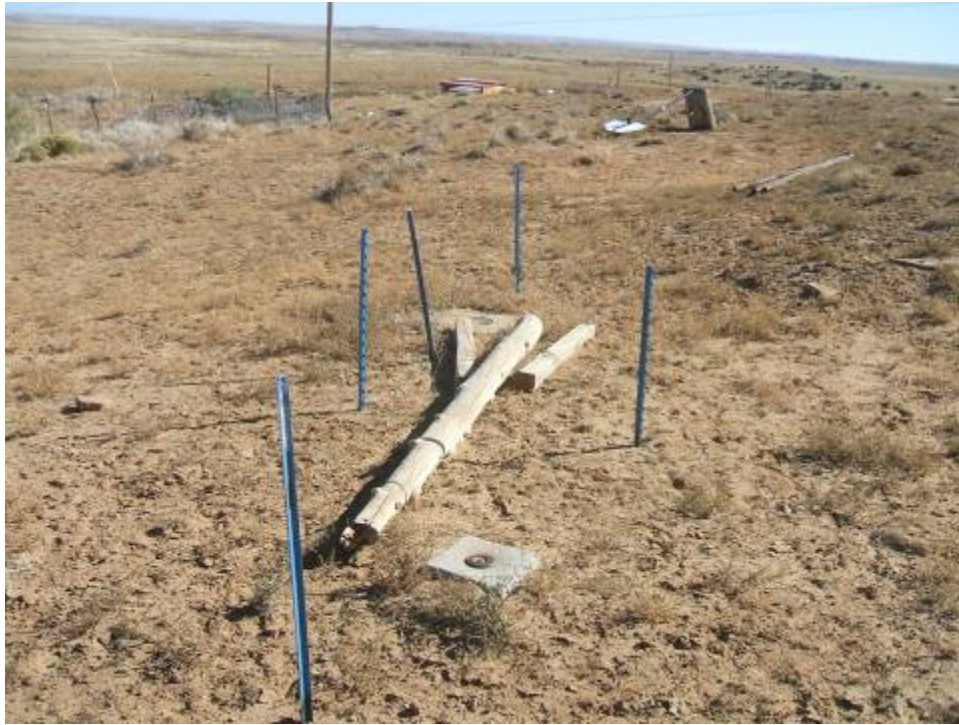
Photo 9. Wells located in northern housing compound, directly northeast of mine site, towards the north

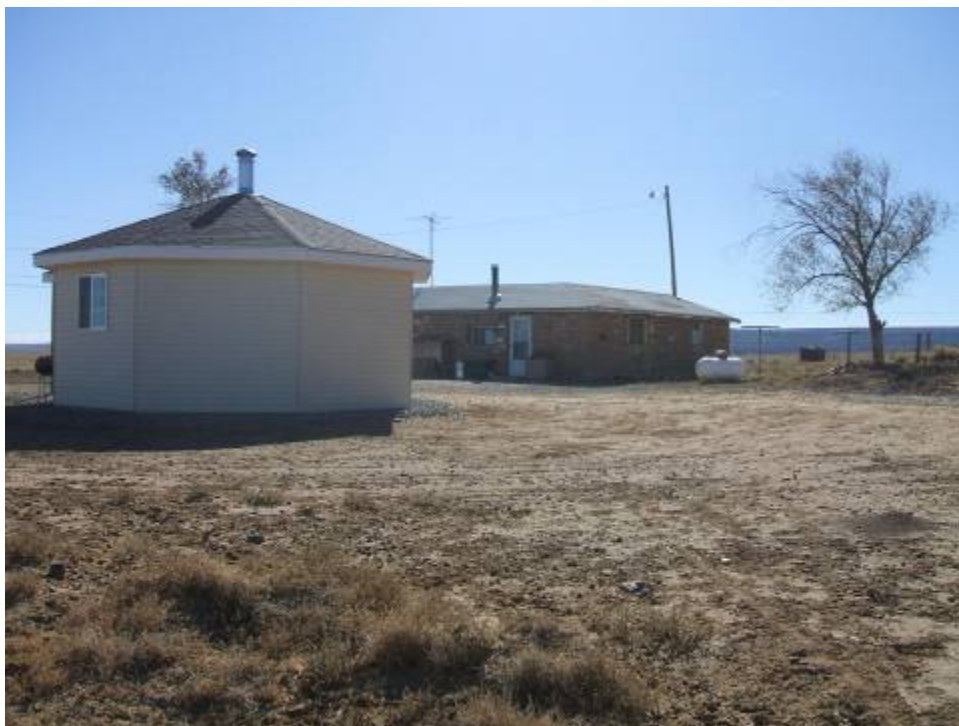
Photo 10. Housing compound directly north of mine site, towards the northeast

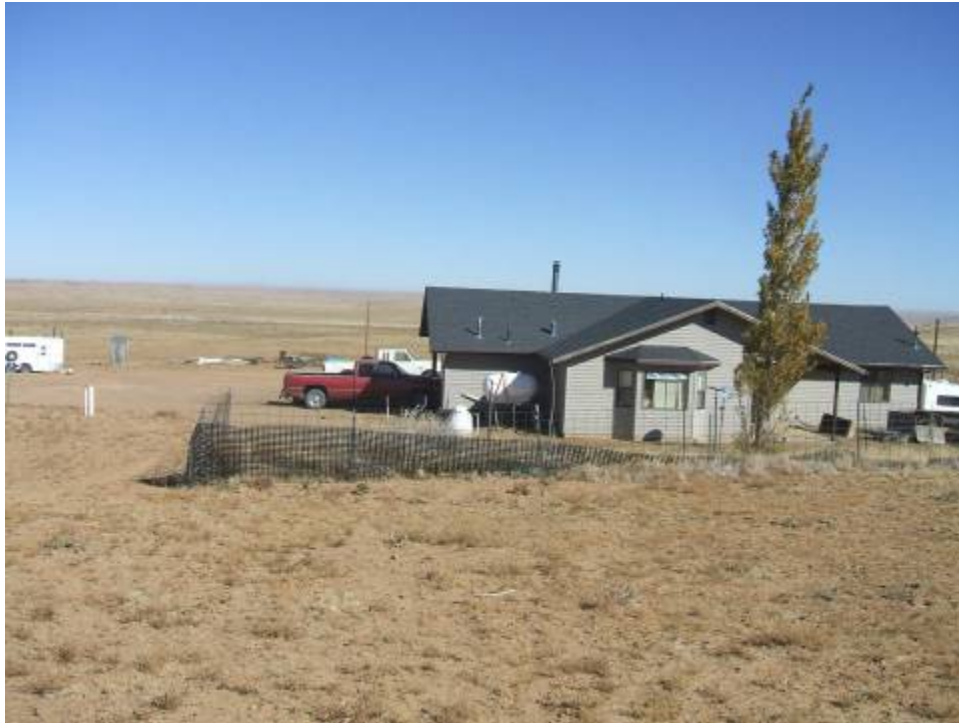
Photo 11. Housing compound directly north of mine site, towards the north

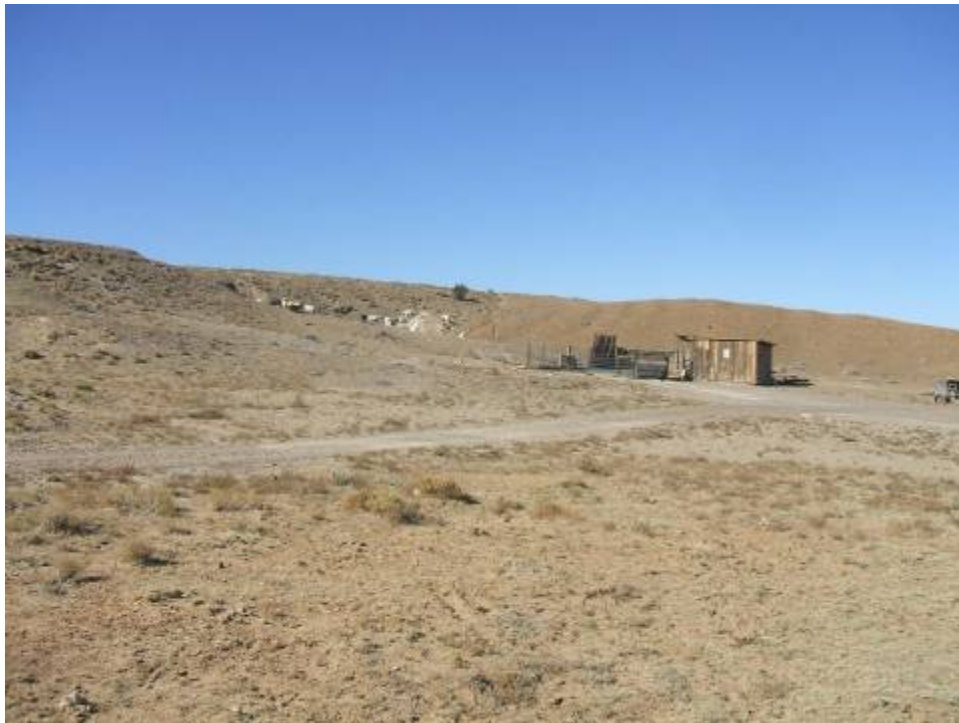
Photo 12. Wooden structure and sheep herd at housing compound directly north of mine site, towards the southwest

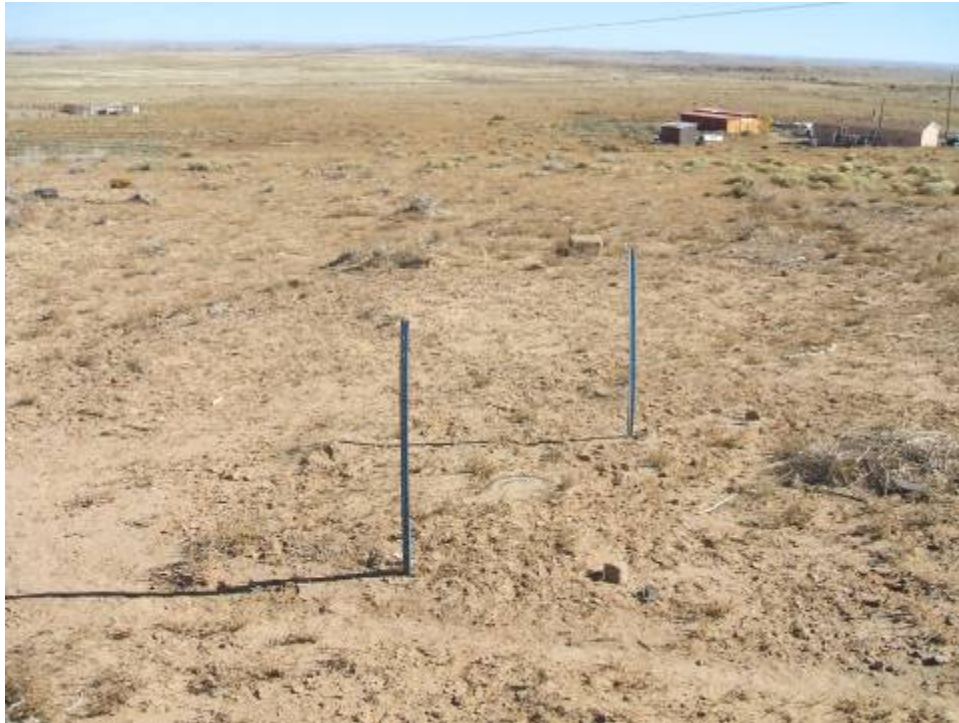
Photo 13. Well located in northern housing compound, directly northeast of mine site, towards the north

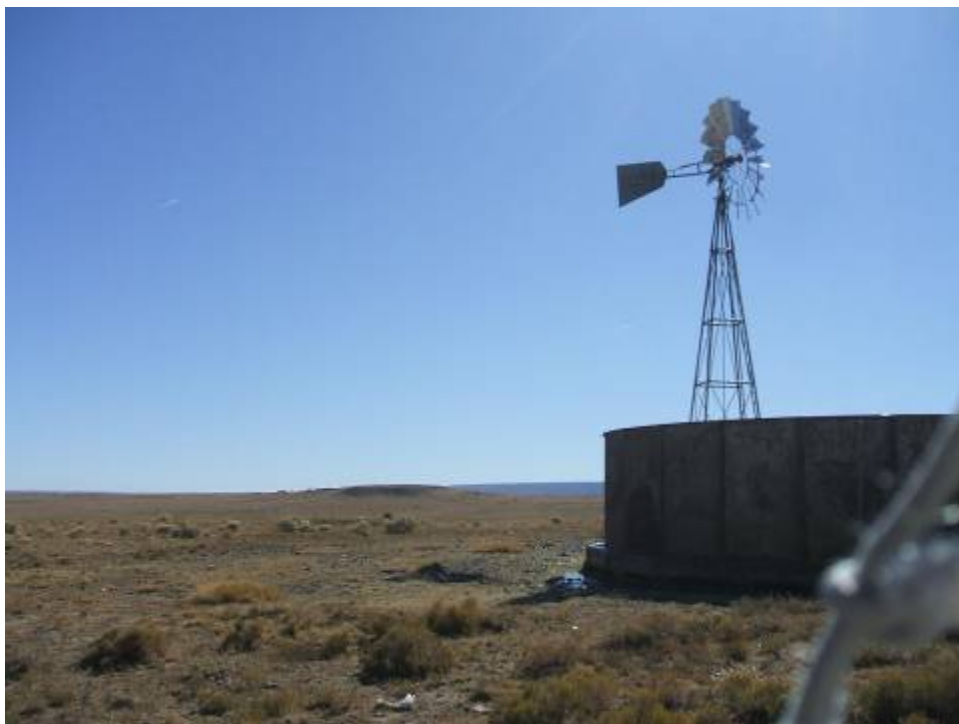
**0.25 miles to 4 miles:** A windmill well was located approximately 1.5 miles west of the site (Photo 14).

Photo 14. Windmill well approximately 1.5 miles west of mine site, towards the east

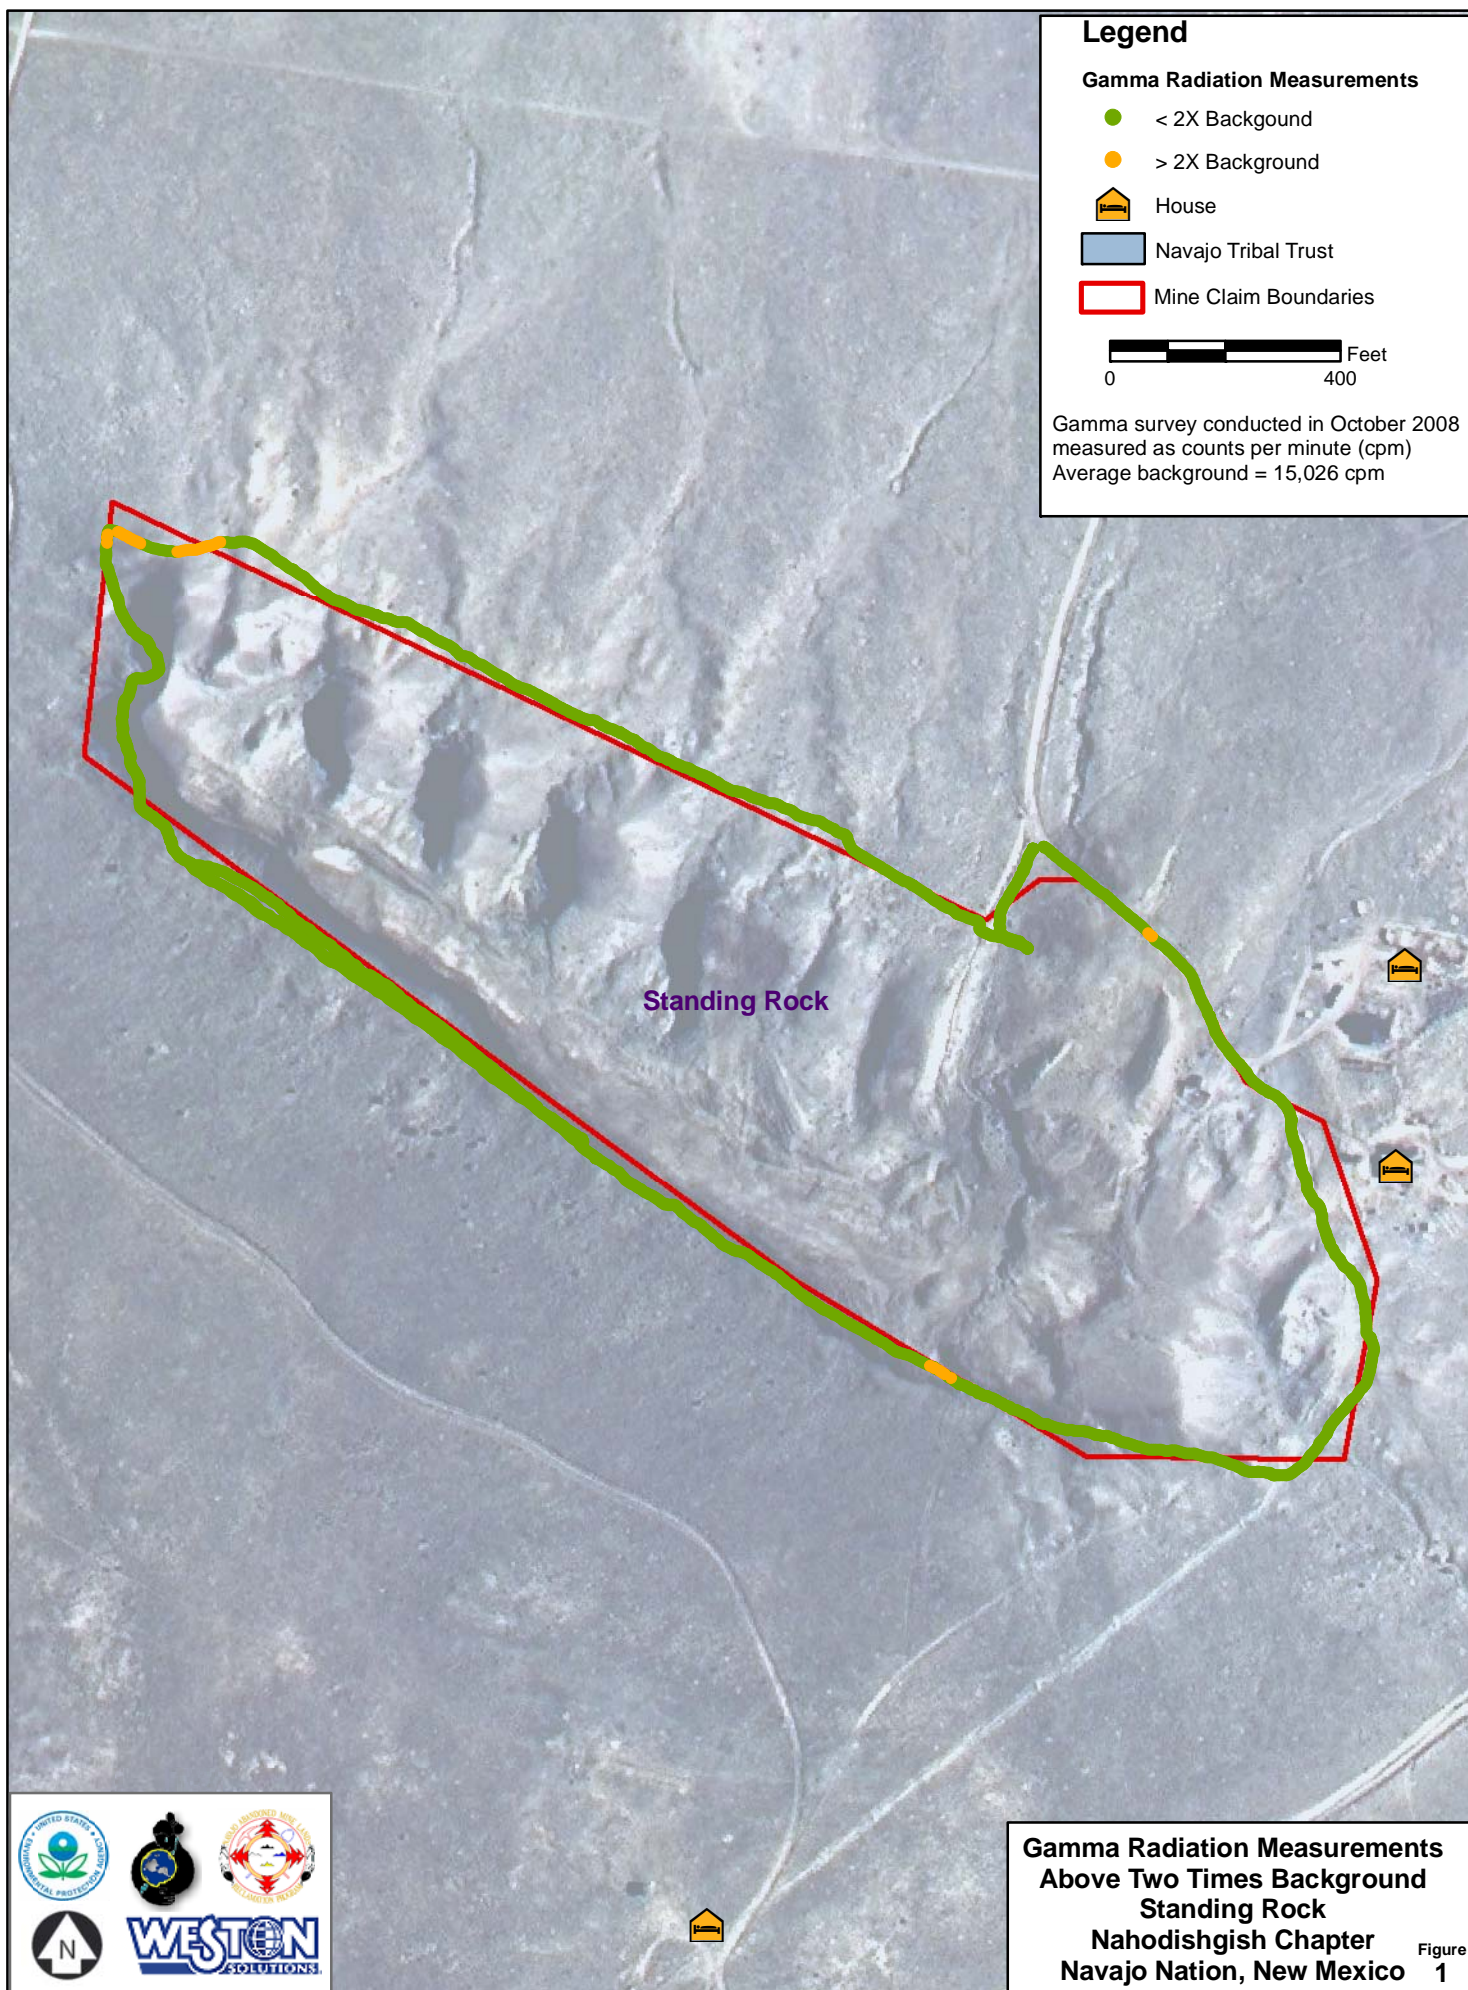
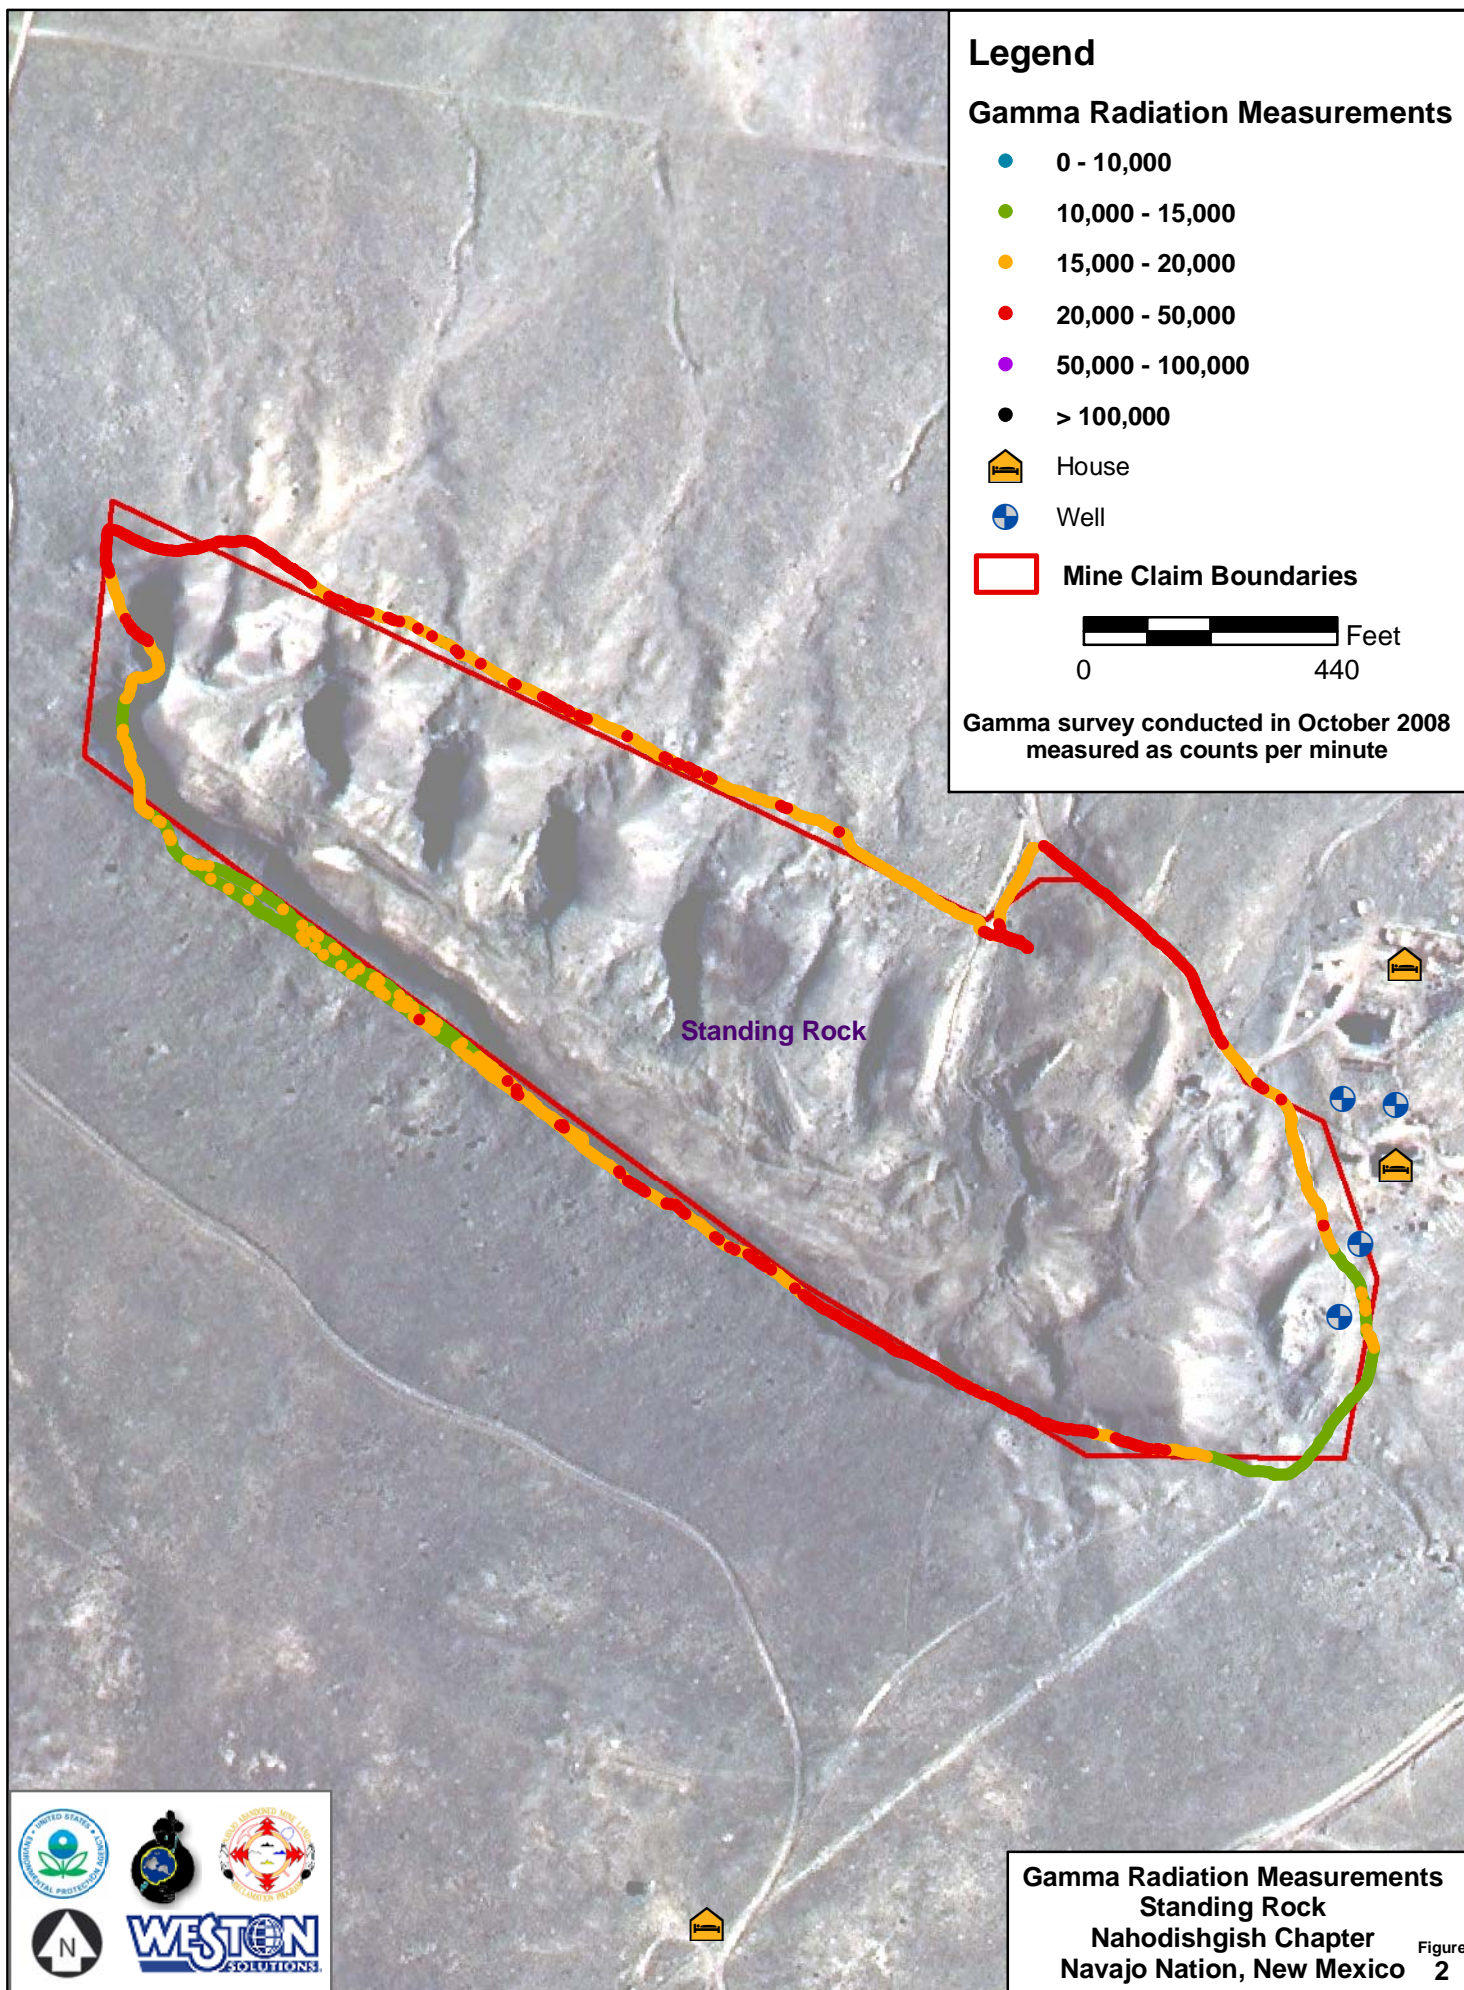
A total of 2,528 gamma radiation measurements were collected from mine sites, ranging from 10,162 cpm to 36,036 cpm. The measurements are represented in Figures 1 and 2.
